University of Natural Resources
and Applied Life Sciences, Vienna
Department of Structural Engineering
and Natural Hazards

THERMAL REFURBISHMENT – assignment of the future

VITA NOVA 2
8.-22. July 2007
Klisura, Bulgaria

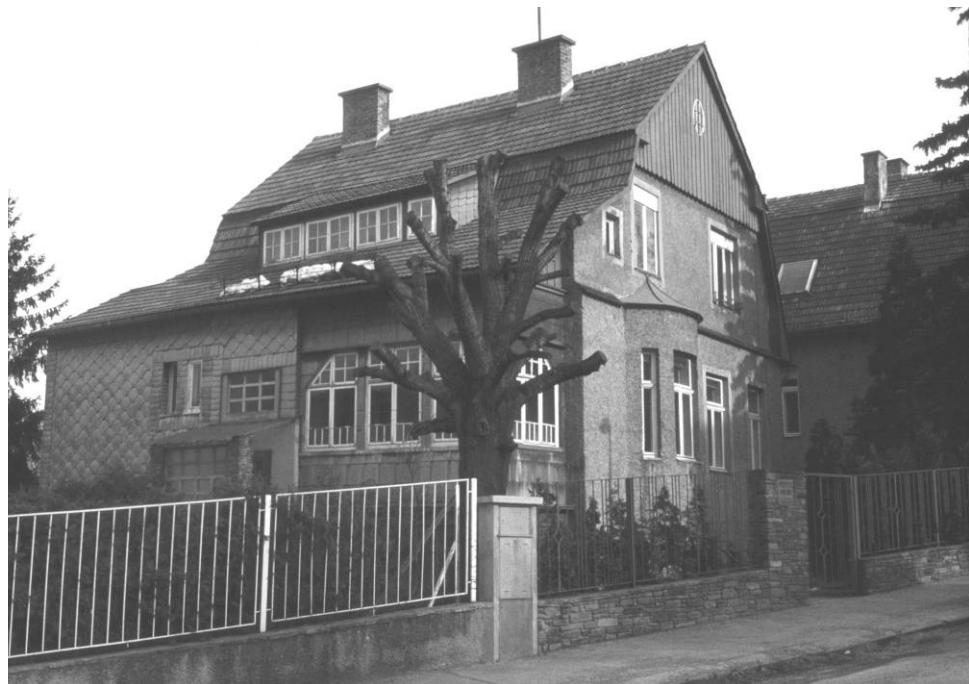
Before reconstruction

Heating energy demand: 340 kWh/(m²a)

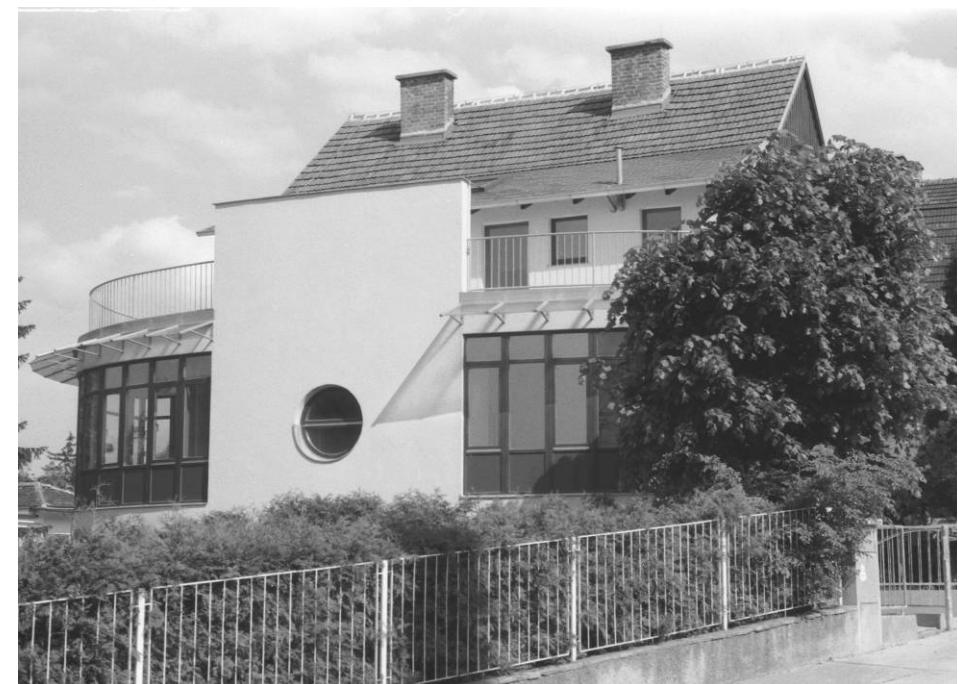
After reconstruction

Heating energy demand: 65 kWh/(m²a)

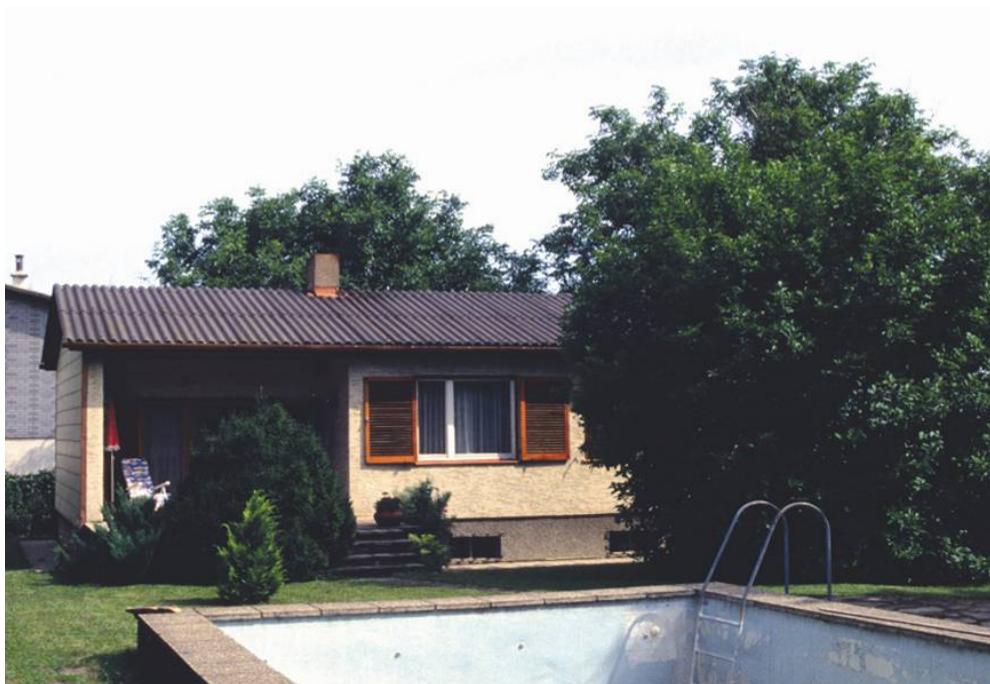
Before reconstruction

Heating energy demand: 370 kWh/(m²a)

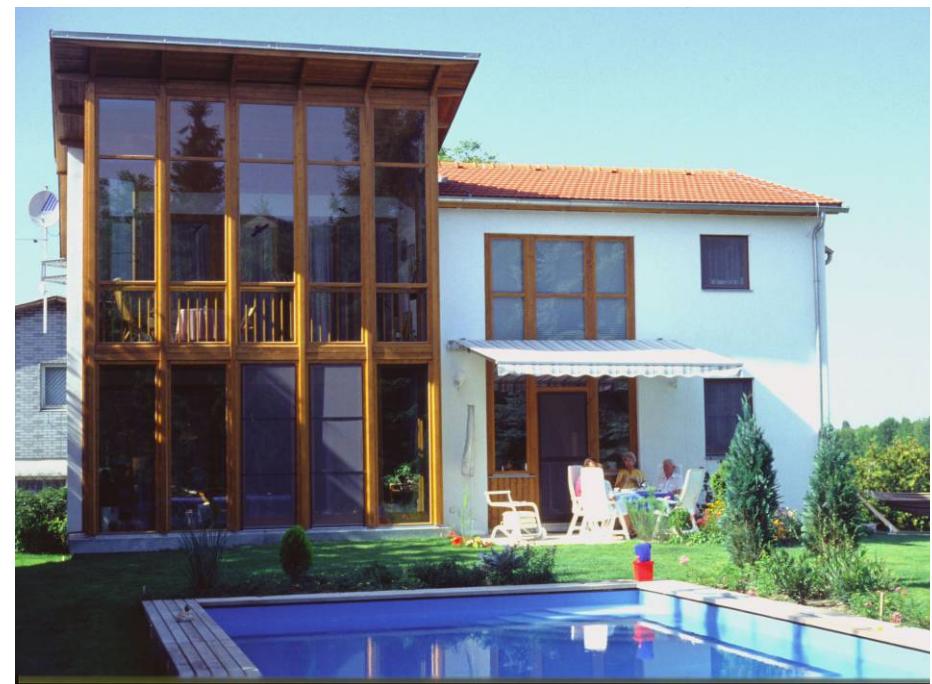
After reconstruction

Heating energy demand: 45 kWh/(m²a)

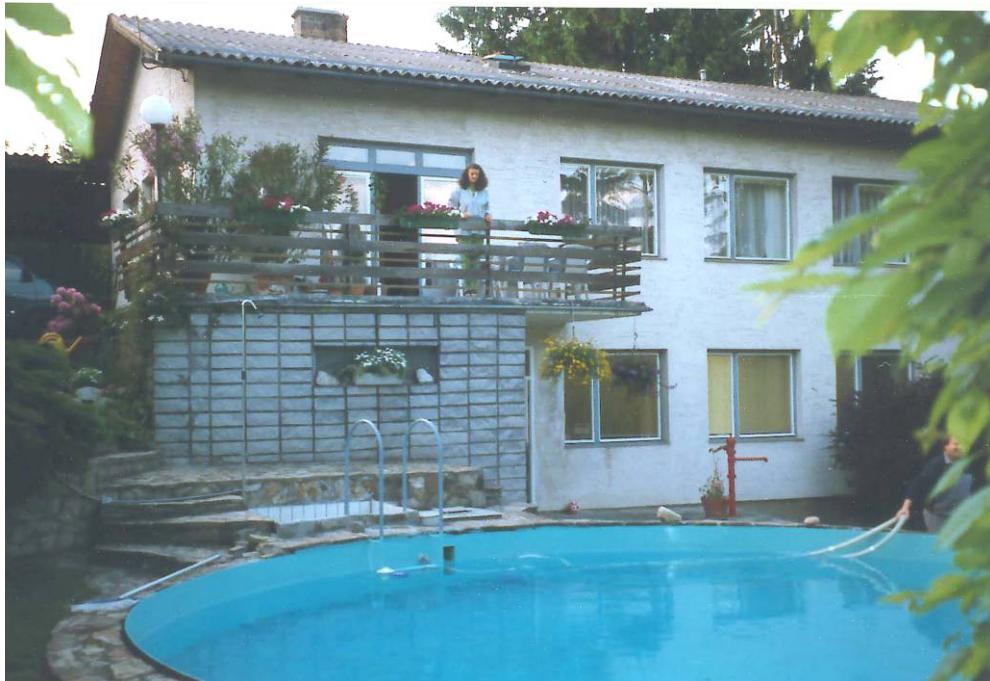
Before reconstruction

Heating energy demand: 300 kWh/(m²a)

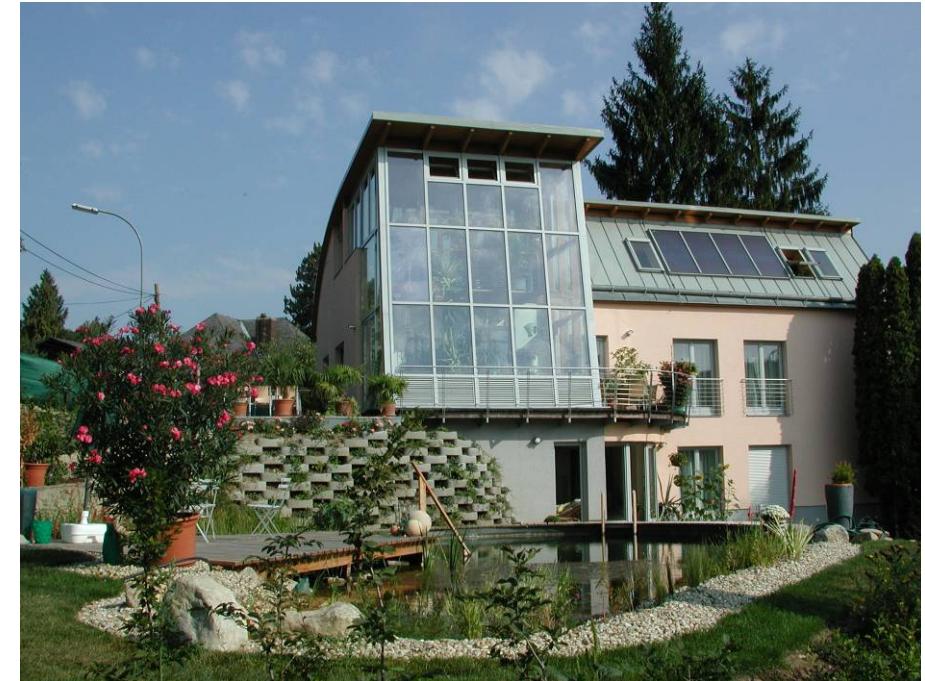
After reconstruction

Heating energy demand: 40 kWh/(m²a)
